## LBYC and RPNYC Mooring repair and reinstatement project July 2021

Date: 9 July 2021

Mooring Joint Owners: Lowry Bay Yacht Club (LBYC) and Royal Port Nicholson Yacht Club (RPNYC)

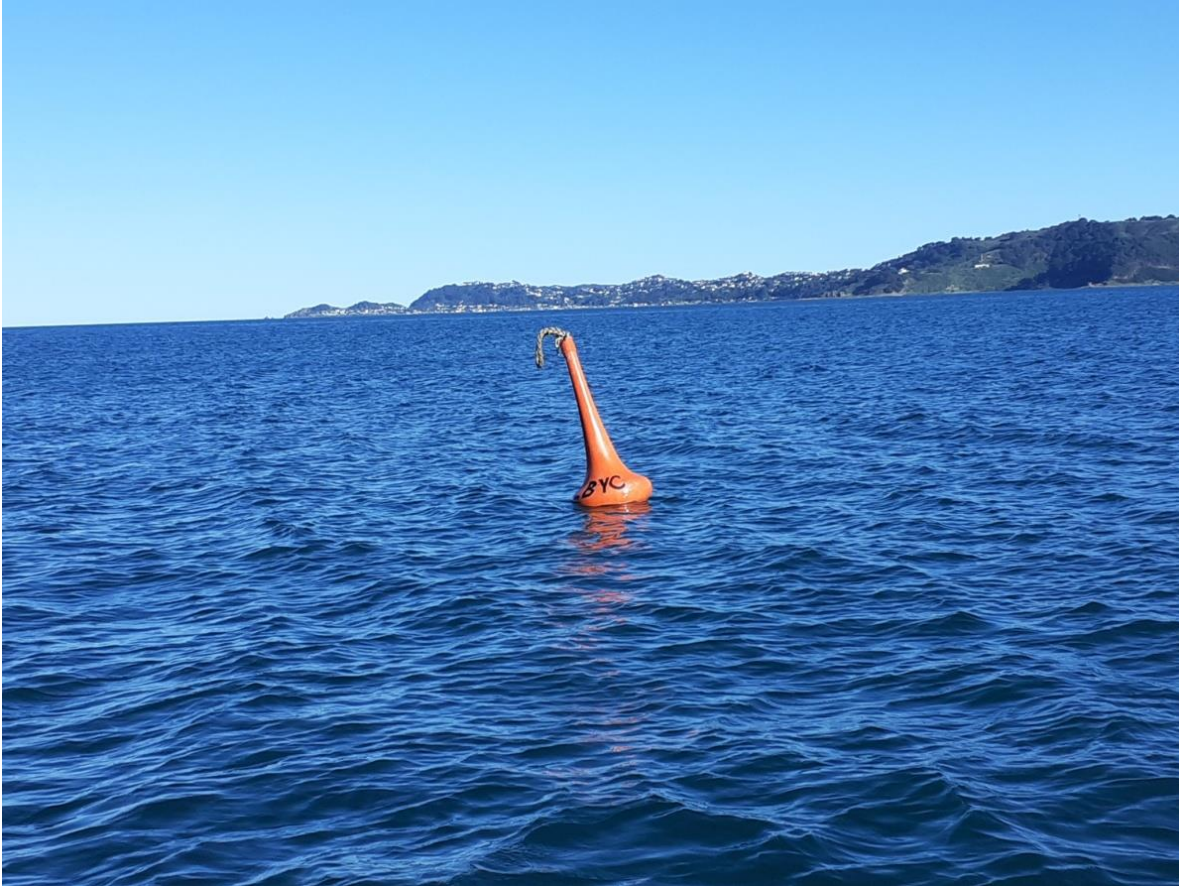
Somes – Matiu South (Fergi Type)

| LBYC / RPNYC Moorings Maintenance 2021 | | | | | | | | | | | | | | | |
|---|---|---|---|---|---|---|---|---|---|---|---|---|---|---|---|
| 1 | South Comes-Matiu | 5.3 | 38 | 7 Fergi Buoy ex Miana installed | 32mm | 0.6 plus 3 kg | 7 | 7 | existing | 1 | 24 | existing no wear | 1 | 1 | Inspection after mainenance: passed previous buoy CC4 cut by sharp object and sunk two spare shackles added as weight for Feri Buoy |

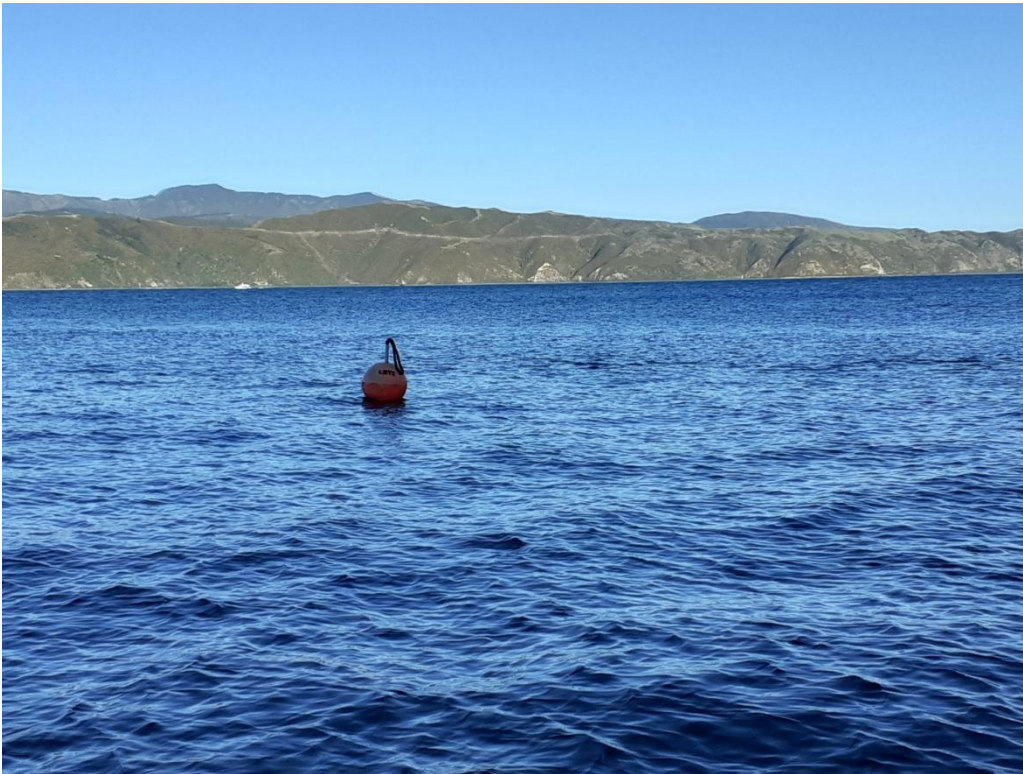
| LBYC / RPNYC Moorings Maintenance 2021 | | | | | | | | | | | | | | | |
|---|---|---|---|---|---|---|---|---|---|---|---|---|---|---|---|
| 2 | Scorching Bay | 3.2 | 20 | 8 CC-4 at RPNYC boat shed | 28mm | 0.6 | 7 | 8 | new ex RPNYC | 1 | | existing ex RPNYC 20 mm | 1 | | Inspection after mainenance: passed Block upside down |

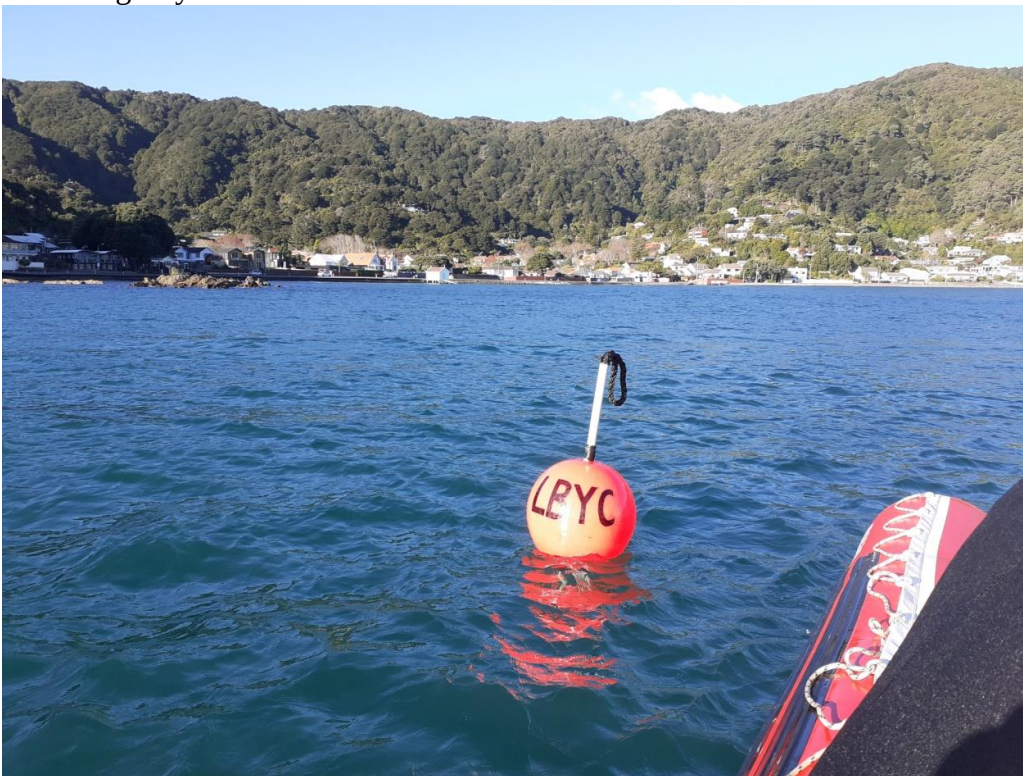
Lowry Bay / Sorento Bay Mooring

| LBYC / RPNYC Moorings Maintenance 2021 | | | | | | | | | | | | | | | |
|---|---|---|---|---|---|---|---|---|---|---|---|---|---|---|---|
| 3 | Lowry / Sorento Bay | 3.2 | 20 | 4 CC-4 locally procured & assembled | 28 mm | 0.6 | 7 | 4 | existing | 1 | | existing 20 mm | 1 | | Inspection after mainenance: passed |

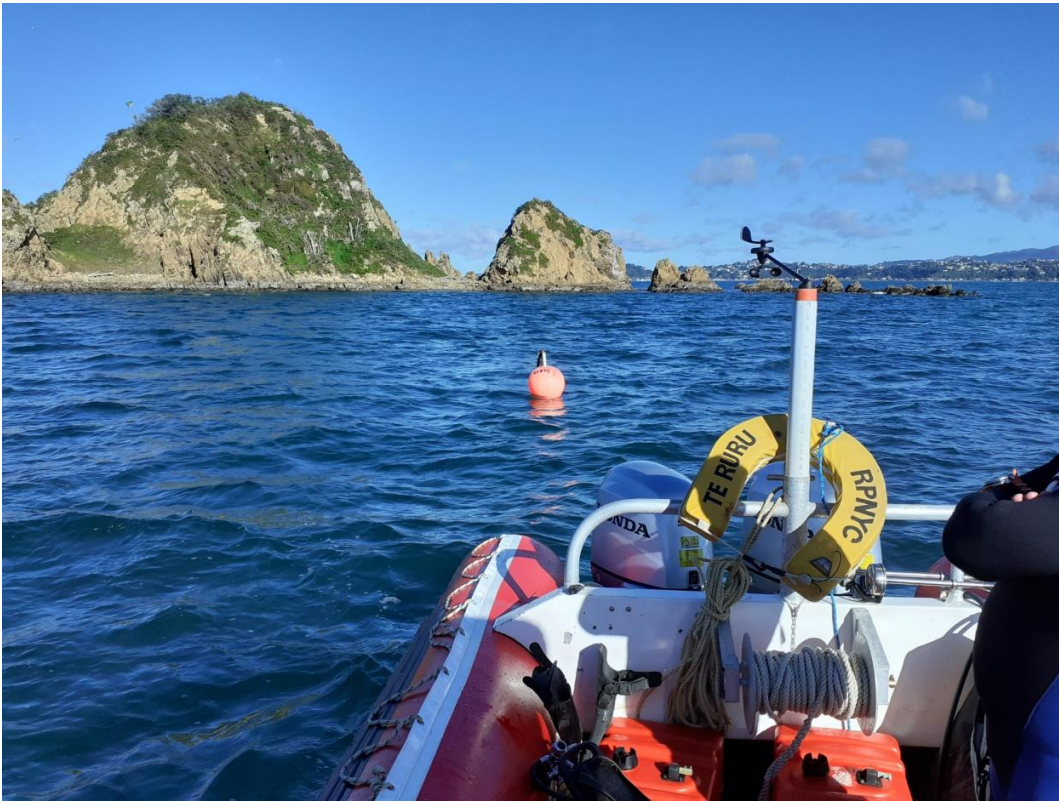
| LBYC / RPNYC Moorings Maintenance 2021 | | | | | | | | | | | | | | | |
|---|---|---|---|---|---|---|---|---|---|---|---|---|---|---|---|
| 4 | Ward Island | 5.3 | 28 | 5 CC-4 existing | 32 mm | 0.6 | 7 | 5 | existing | 1 | | existing 24 mm worn to 20 mm | 1 | | Inspection after mainenance: passed |

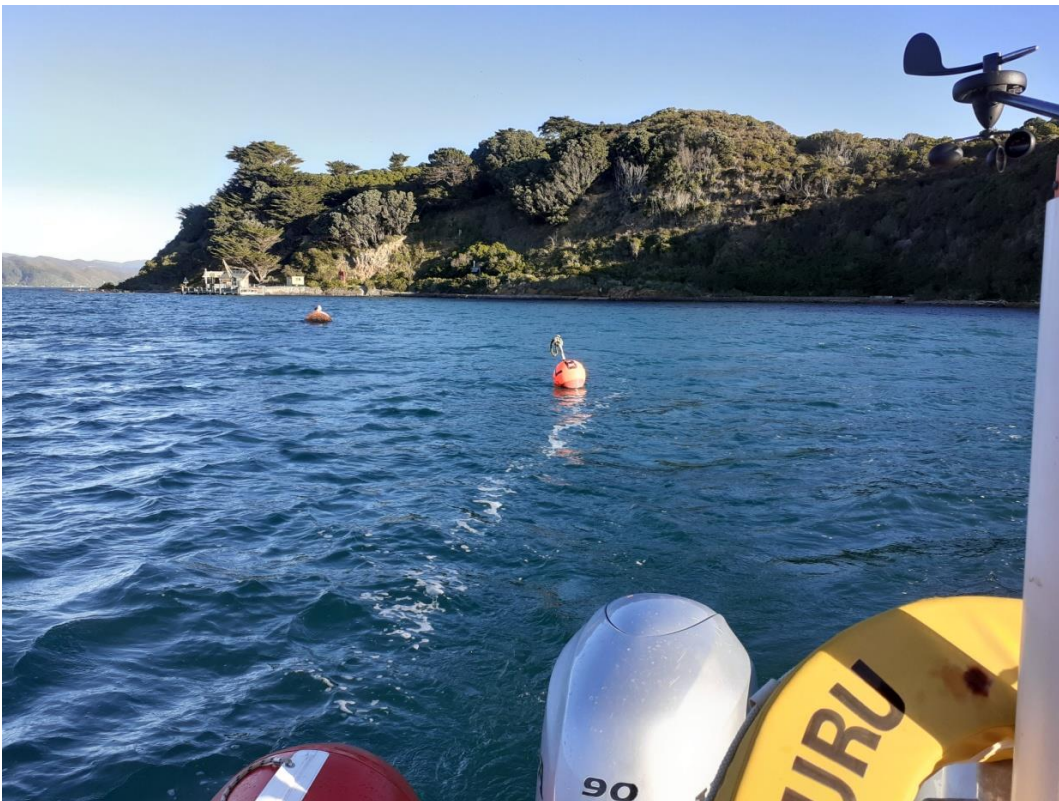
Somes - Matiu North

| LBYC / RPNYC Moorings Maintenance 2021 | | | | | | | | | | | | | | | |
|---|---|---|---|---|---|---|---|---|---|---|---|---|---|---|---|
| 4 | Noth Comes-Matiu | 2 | 15 | 9 CC-4 existing | 32 mm | 0.6 | 7 | 9 | existing | 1 | | existing 25 mm | 1 | 32 mm | Inspection after mainenance: passed mooring had shifted southwards stopped by a rock wall Pipe had slipped down, pushed back, held with cable ties |

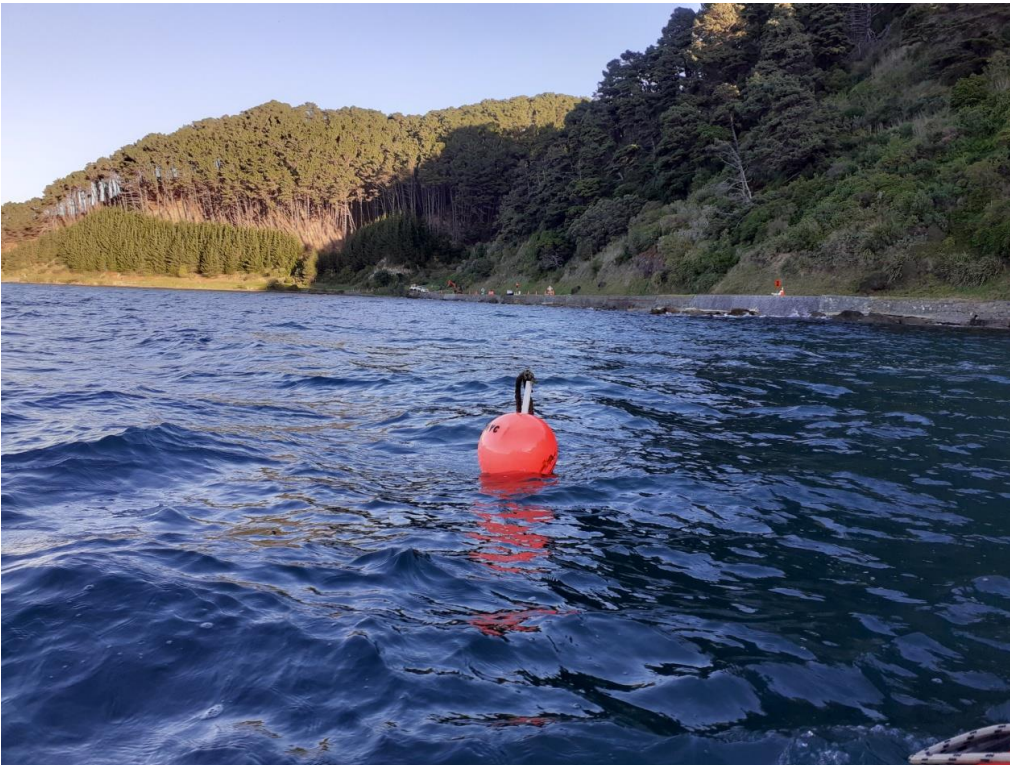
| LBYC / RPNYC Moorings Maintenance 2021 | | | | | | | | | | | | | | | |
|---|---|---|---|---|---|---|---|---|---|---|---|---|---|---|---|
| 4 | Kau Bay | 5.3 | 38 | 6 CC-4 existing | 32 mm | 0.6 | 7 | 6 | existing | 1 | | existing 20 mm | 1 | | Inspection after mainenance: passed |

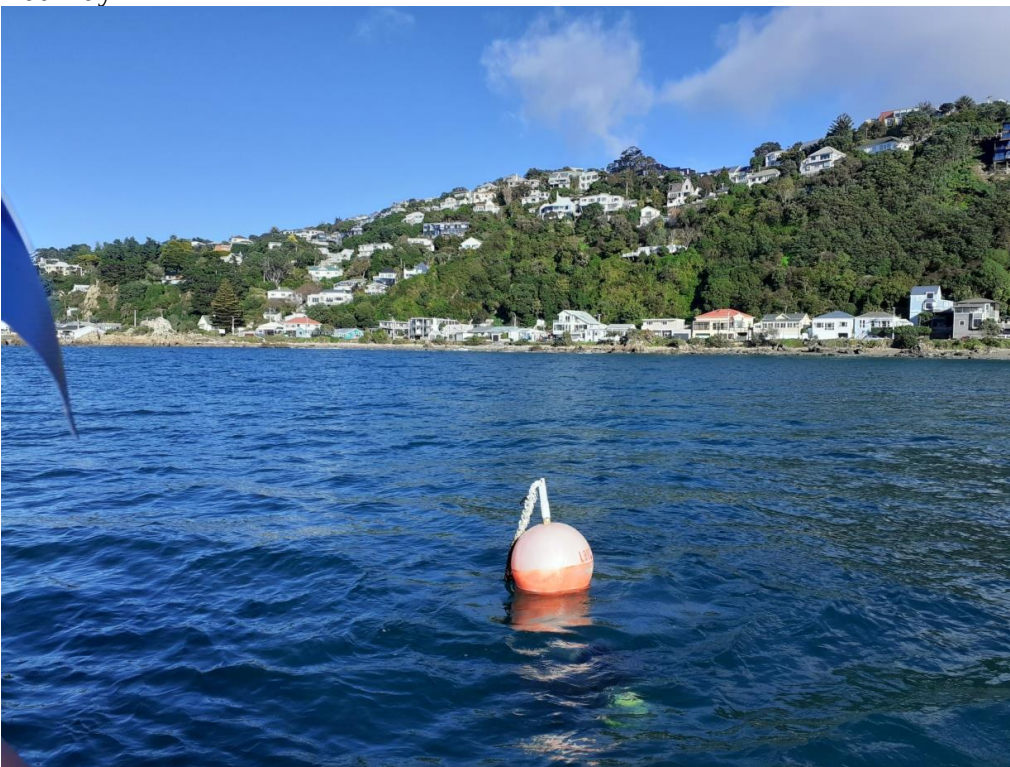
Seatoun / Worser Bay

| LBYC / RPNYC Moorings Maintenance 2021 | | | | | | | | | | | | | | | |
|---|---|---|---|---|---|---|---|---|---|---|---|---|---|---|---|
| 4 | Seatoun/Worser | 3.2 | 20 | 8 CC-4 existing | 32 mm top only | 0.6 | 7 | 8 | existing | 1 | | existing 22 mm stud-link | 1 | | Inspection after mainenance: passed spring chain remaining diameters: > 18 mm Block on side |
